Device Errata

Skywire® Modem

NimbeLink // Products
Published // June, 2015

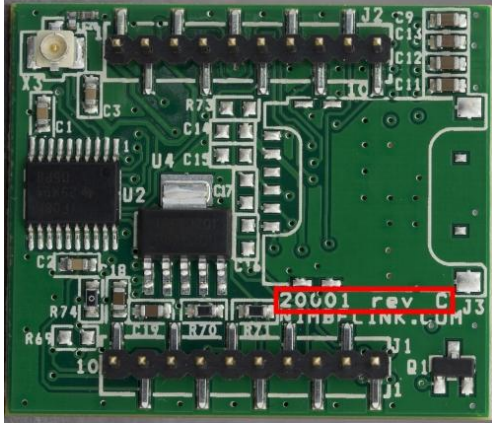
The PCB revision is found on the bottom side of the modem between J1 (Skywire interface connector) and J3 (Micro-SIM socket). The revision is written in white silkscreen and is of the form 20001 rev X.

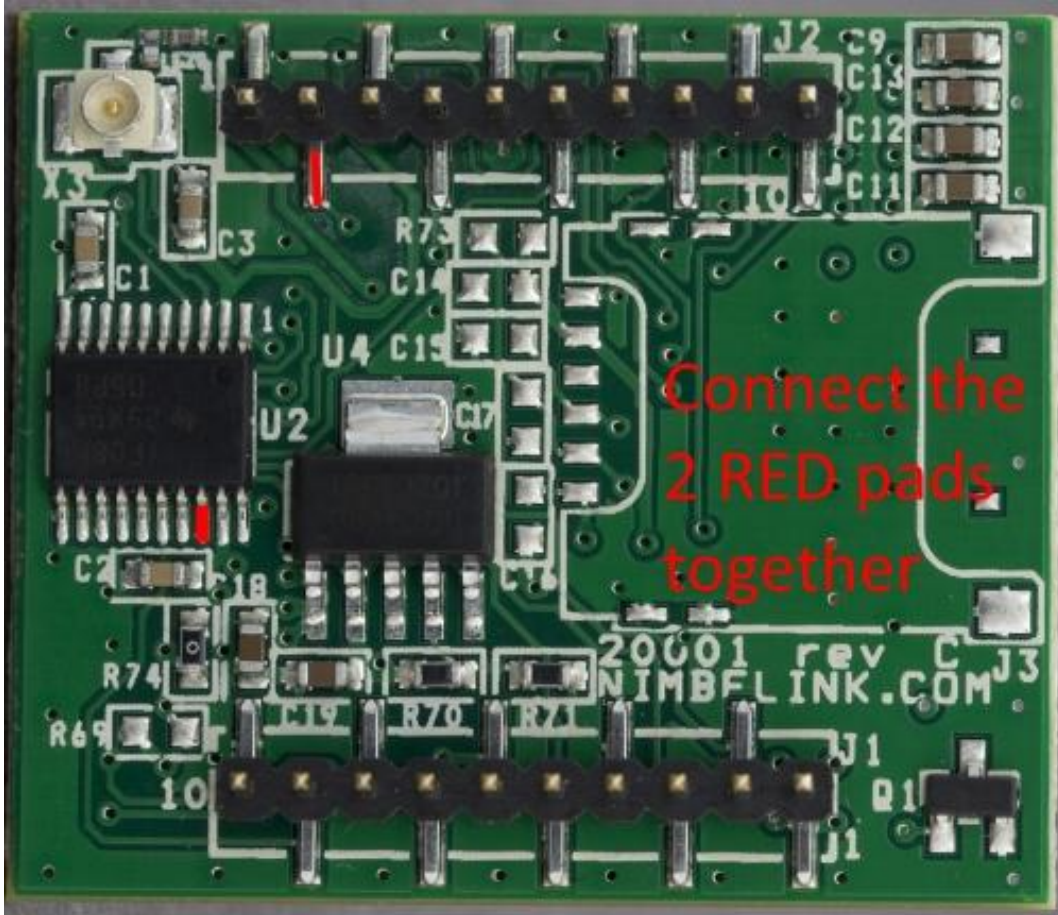
This Errata affects applications requiring use of the UART CTS hardware flow control output from the Skywire modem. The UART CTS signal (Pin 12 on the Skywire interface) is not connected on NimbeLink PCBs prior to PCB revision F. This Errata does not affect your design if any of the following are true:

The Errata can be repaired on affected product by soldering a wire to the underside of the modem. The wire must connect Skywire interface pin 12 to U2 pin 18. Adding this wire will not invalidate the product warranty, however, poor workmanship can damage the modem and invalidate the warranty.
