Device Errata

NL-SW-LTE-S7618RD

NL-SW-LTE-S7648

Skywire[®] Modems

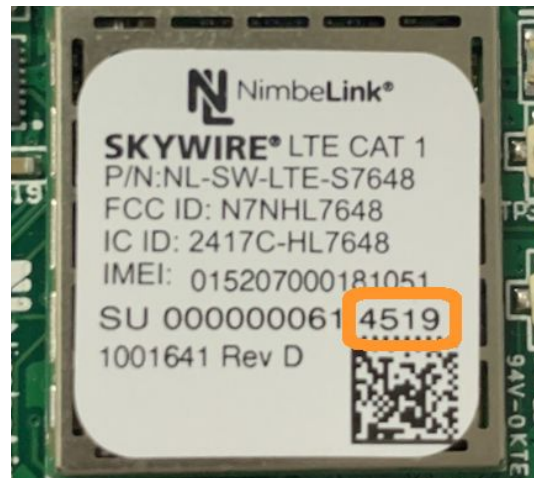
Devices with the following date codes are affected:

- 4519
- 4719
- 4819
- 4919
- 5319
- 0120
- 0920

The date code is the last four digits of the modems serial number located on the modems label.

- Issue AT+KSLEEP=1 command to the modem over the USB interface to restore the default KSLEEP state.
- Assert the DTR pin low from the host controller.
- Ground the DTR pin with a 1K Ohm pull down resistor or, if the DTR signal is not going to be connected to a host controller, tie DTR directly to ground.
