Environmental Tests on
(3) RECON13 Antennas (Ribbed Surface) and
(3) RECON13 Antennas (Flat Surface)

For	Airgain Inc 7860 E McClain Dr, Ste 2 Scottsdale, AZ 85260
P.O. Number	4000079383
Date Tested	11/8-10/2023
Test Personnel	David Way
Test Documents	Airgain RECON13 SOW_09-25-2023 ISO 20653 Edition 2.2 (2013-08)

Elite Electronic Engineering Inc.

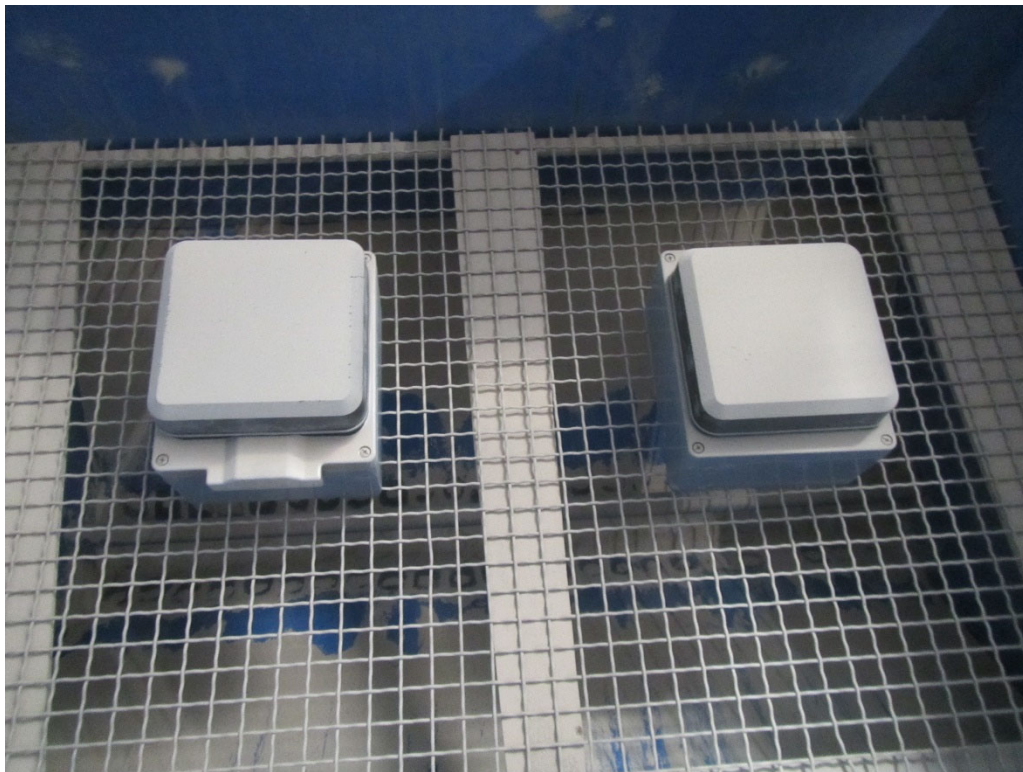
Post-Test Photograph

The DUTs completed the Dust testing per Airgain RECON13 SOW_09-25-2023 with reference to ISO 20653 Edition 2.2 (2013-08) IP6K. Following the test, the DUTs were visually inspected for physical damage and dust intrusion. The DUTs had no evidence of physical damage or dust intrusion. The DUTs were then returned to the customer for further evaluation.

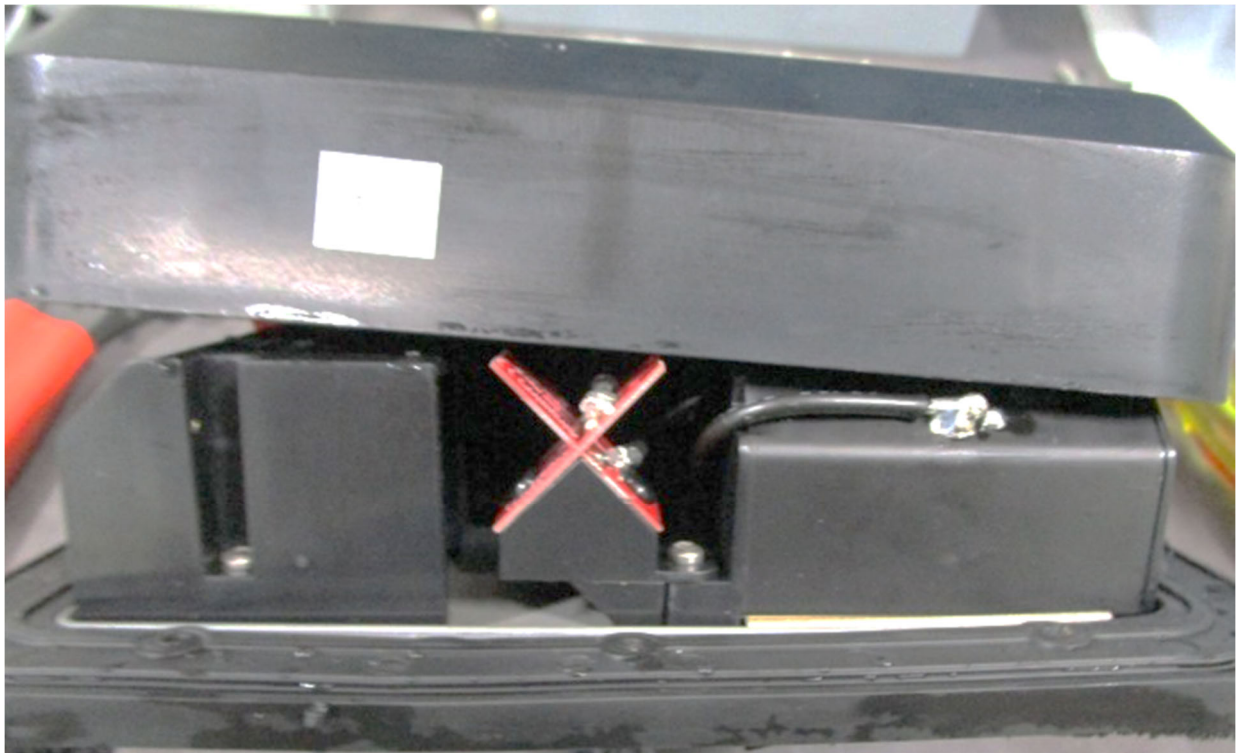
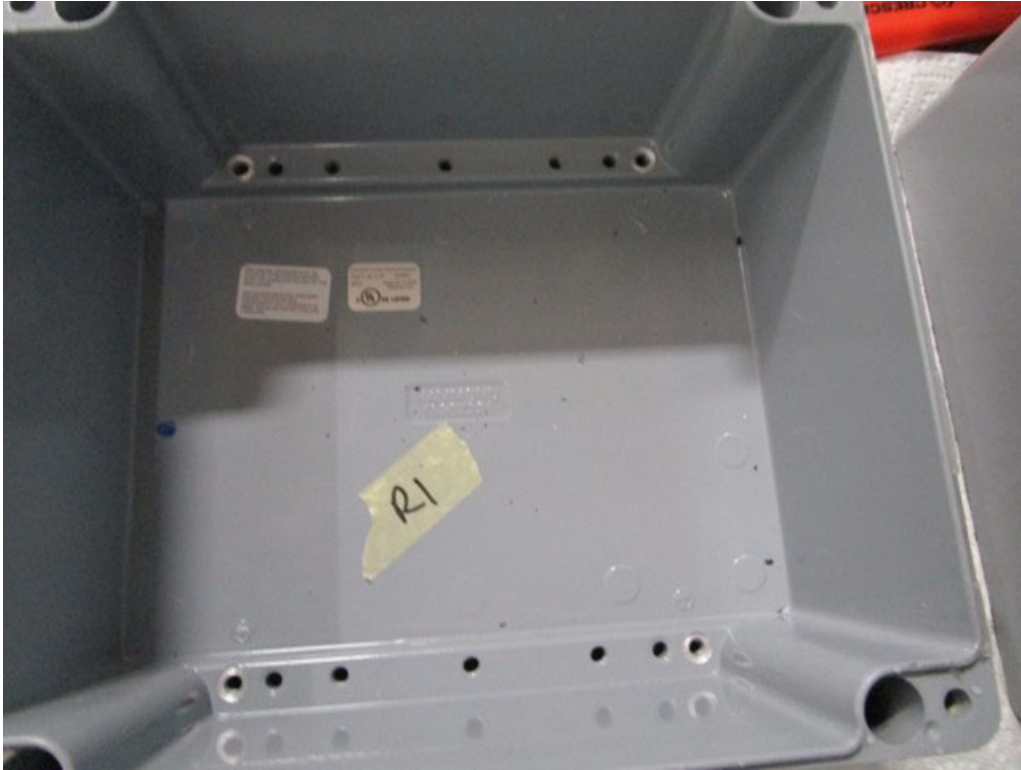
DUT 3 Post-Test Photograph

The DUTs were subjected to and completed the Immersion testing per Airgain RECON13 SOW_09-25-2023 with reference to ISO 20653 Edition 2.2 (2013-08) IPX7. There was no evidence of water intrusion after the thirty (30) minutes of immersion. Following the test, the DUTs were returned to the customer for further evaluation.

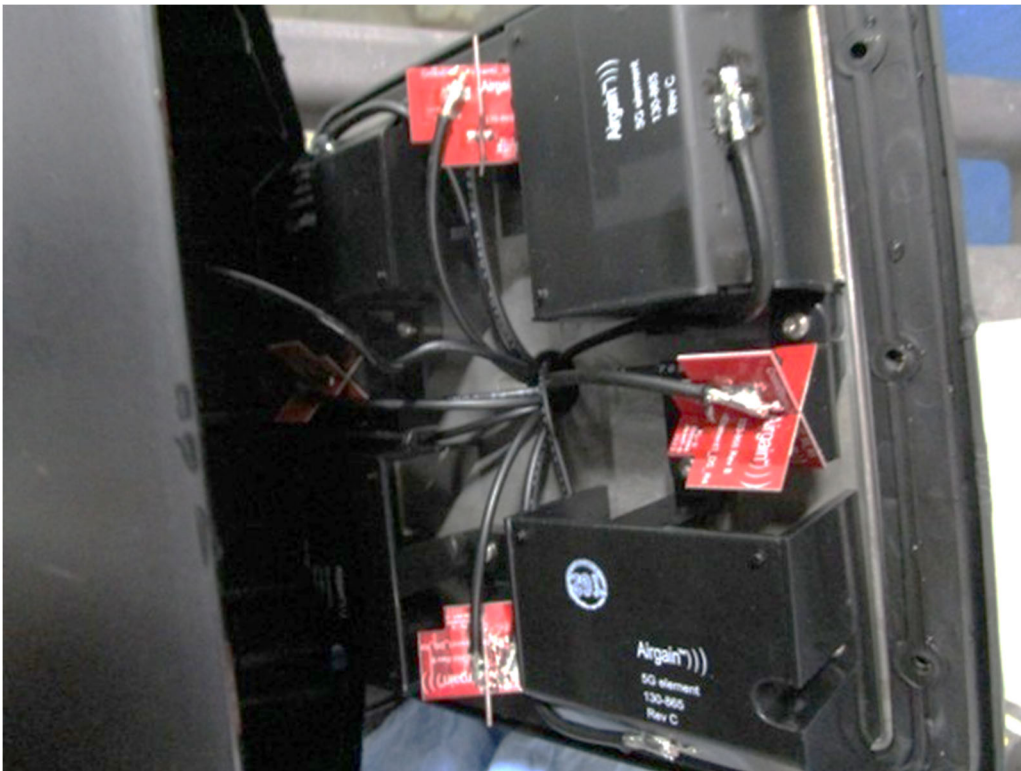
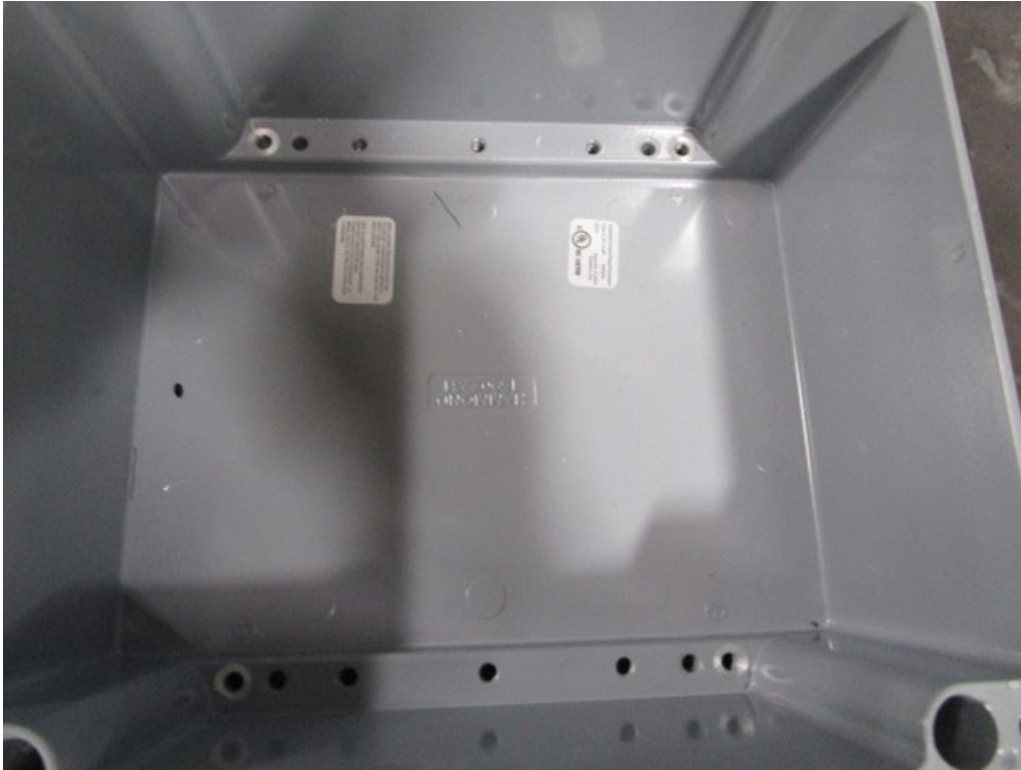
DUT 2 Post-Test Photograph

The DUTs were subjected to and completed the Pressure Spray testing per Airgain RECON13 SOW_09-25-2023 with reference to ISO 20653 Edition 2.2 (2013-08) IPX9K. Following the test, the DUTs were visually inspected for physical damage or water intrusion. The DUTs had no evidence of physical damage or water intrusion. The DUTs were then returned to the customer for further evaluation.
