Test Report

Report No.:H201904168357-02EN

Sample description: Double Cell and Wi-Fi Antenna with GNSS

Sample model: AP-M2M2-CCWWG-Q-S22222-RP34-BL

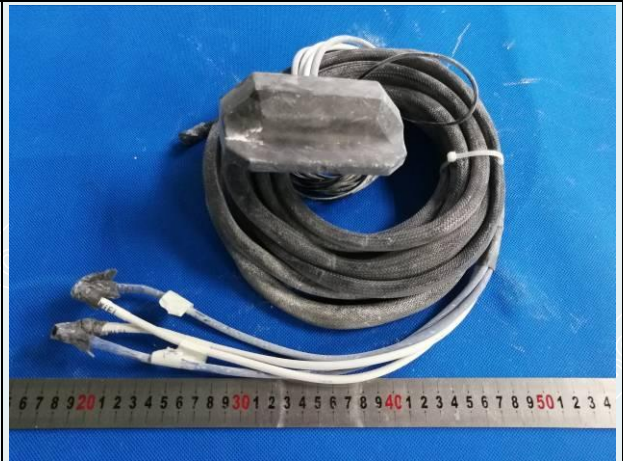
Fig.1-2 Post-test sample

Sample name	Test No.	Visual inspection	Conclusion
Double Cell and Wi-Fi Antenna with GNSS	H201904168357-3#	A 1.0 mm diameter probe can't pass through the opening. After the test, there was no deposit of dust inside the sample.	Meet the requirements

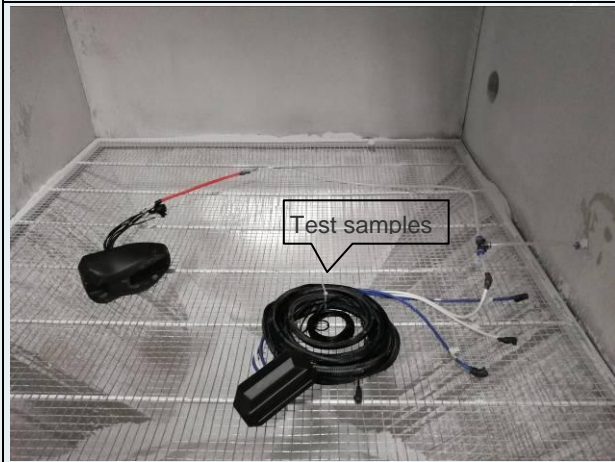
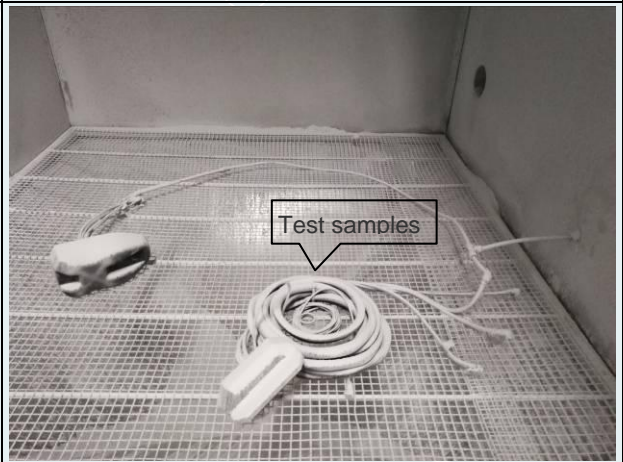
Fig.1-3 IP6X (1)

1.1.3 IP6X test conditions: The talcum powder used shall be able to pass through a square-meshed sieve the nominal wire diameter of which is 50 μ m and the nominal width of a gap between wires 75 μ m. The amount of talcum powder to be used is 2kg per cubic metre of the test chamber volume.

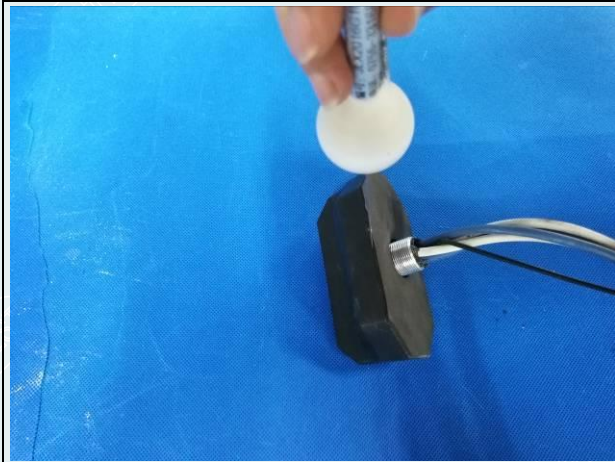
Fig.1-5 Probe test

1.1.2 Probe test: Samples were metal proofed using a 1.0 mm diameter metal probe;

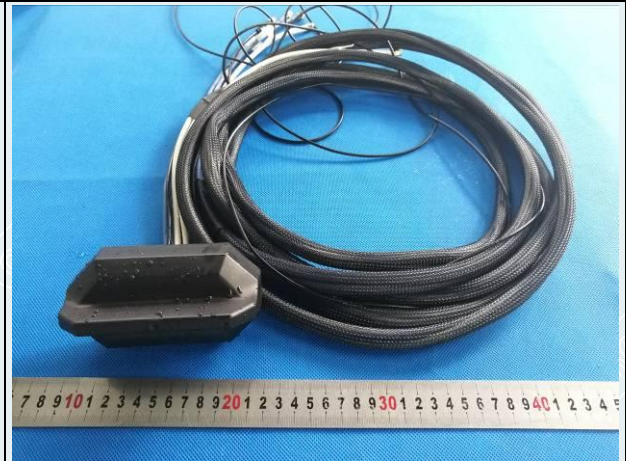
Fig.2-2 Post-test sample

Sample name	Test No.	Visual inspection	Conclusion
Double Cell and Wi-Fi Antenna with GNSS	H201904168357-4#	After the test, no water was found into the sample.	Meet the requirements

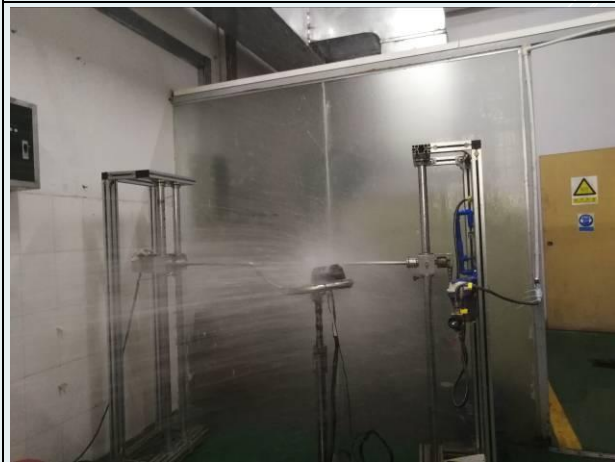
Fig.2-3 IPX6

2.1.2 Internal diameter of nozzle: 12.5mm;

2.1.3 Delivery rate: 100L/min±5%;

2.1.4 Test duration: approximately 3min;

2.1.5 Distance form nozzle to be the equipment surface: 2.5m~3m.
