Test Report

Report No.:H201904165155-02EN

Sample description: Double Cell and Wi-Fi Antenna with GNSS

Sample model: AP-M2M2-CCWWG-Q-S22222-RP34-BL

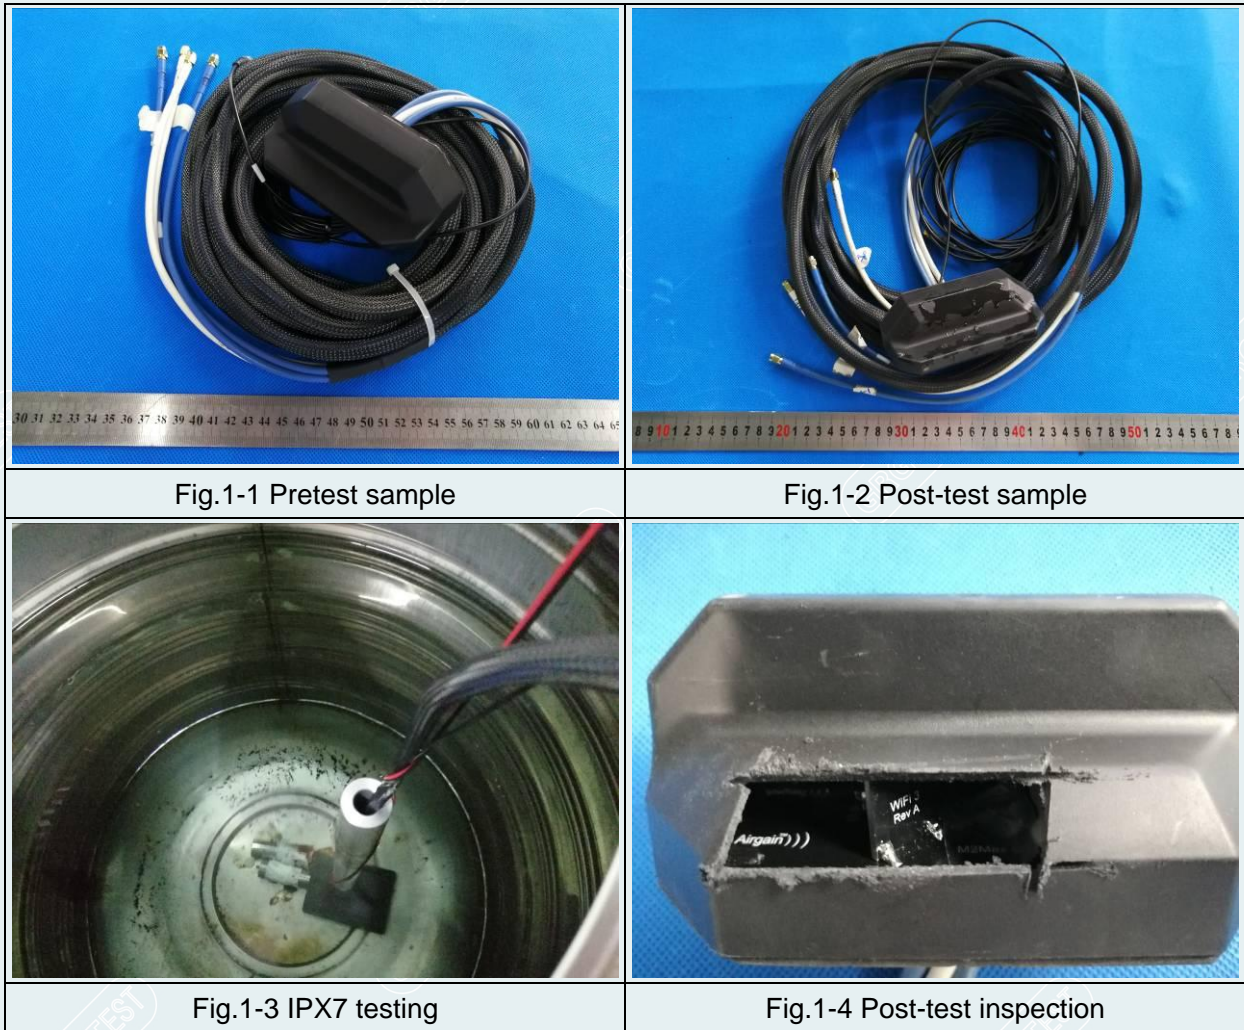
1.5 Test photos

Sample	Test No.	Visual inspection	Conclusion
Double Cell and Wi-Fi Antenna with GNSS	H201904165155-2#	After the test, no water was found into the sample.	Meet the requirements

Fig.1-1 Pretest sample

Fig.1-2 Post-test sample

Fig.1-3 IPX7 testing

Fig.1-4 Post-test inspection
